## Improving Scrap Rate on a Film Core Line

### Background

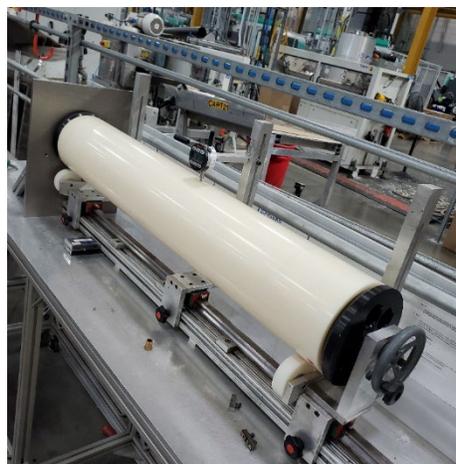
*Large Diameter Core Extruded on I12*

For most of 2021, the scrap rate averaged higher than target. The large parts extruded on I12 require large quantities of plastic, slower running speeds, and tight tolerances, all factors that make it harder to control scrap. Previous projects aimed at improving the rate on I12 had initially been successful but had not been sustainable. The team taking the Yellow Belt class sought to apply the principles they had been learning and see if they could finally tackle it.

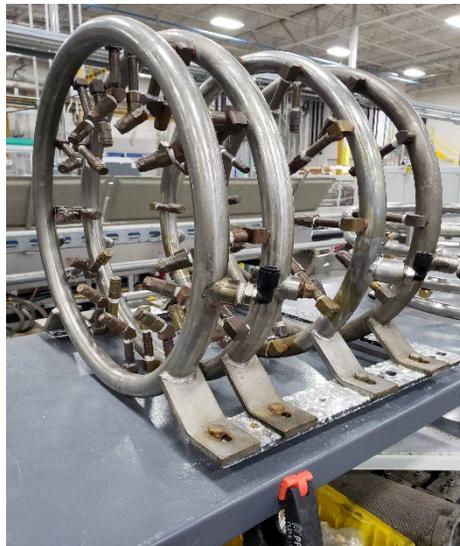
After analysis, the team decided on several main approaches to improvement. First, they determined that increasing the standardization and precision of equipment placement at startup would help. One setup improvement was to use laser alignment technology during cooling tank installation. Another was to add information to the setup sheets used by technicians, including equipment position notes and flow parameters. Finally, a key standardization improvement was the development of metal quick-change plates onto which the spray rings could be affixed using pre-drilled holes. Instead of

*Spray Rings on a Newly Developed Quick-Change Plate*

requiring technicians to place each individual ring in the correct location, they are now added to plates that place the rings in the precise locations required for a given part. The quick-change plates increase accuracy by eliminating setup error, and they reduce labor time because they can be quickly removed as a unit and added as needed.

Second, problems with the placement of initial tooling and incorrect sizing adjustments on startup also impacted scrap rate. One of the primary setup issues identified was difficulty in proper cooling setup involving the placement of spray rings in the appropriate locations. Spray rings are large metal rings located in the front of the cooling tank. They spray the hot parts with water as they run through the rings, serving

as an initial means of cooling and hardening parts into place. Different parts require different ring locations, and incorrect placement can contribute to scrap.
