# Developing a Test Method to Determine the Cause of a Cracking Cosmetic Product

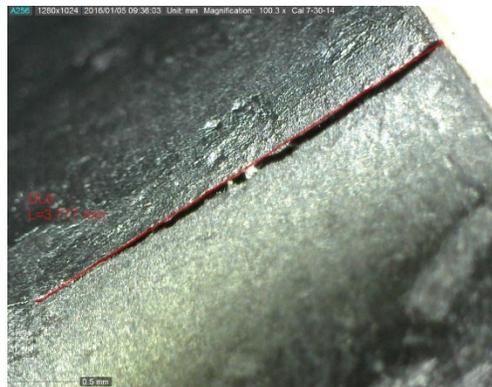
TAL started the testing process by first replicating the customer's observations, mimicking the same heat conditioning test they had conducted. A sample pen filled with cosmetic was capped and placed in an oven at 50°C and monitored every 24 hours, while an identical control sample was left out of the oven and monitored on the same schedule. At the first 24-hour check of the heated sample, liquid was leaking out of the barrel between the polypropylene end cap and barrel seam. This liquid was analyzed by FT-IR testing and found to have similarities to silane, a solvent. After a week, TAL observed cracking in the heated sample at the seam where the initial leaking was observed, just as the customer had said.

*Cracking present on heat-tested AES barrel sample.*

TAL concluded that the cracks may have been the product of environmental stress cracking, which occurs when there is a combination of applied pressure and another contributing environmental factor. In this case, TAL believed the silane, solvent-based cosmetic was likely the environmental factor weakening the AES barrel material enough to lead to cracking as the cap and barrel expanded under heat.

TAL concluded that the cracking observed in the parts was environmental stress cracking. The stress-induced cracking from heat expansion was accelerated by a solvent in the cosmetic formulation.

1. Reduce the heat of the initial conditioning test. Perhaps 50°C was too aggressive and the product would perform without issue at a slightly lower temperature, and perhaps that would be all that was needed to assess the quality and reasonable life of the product.
2. Reduce the dimensions of the barrel or cap. Perhaps the dimensions were at a tipping point and a slight size reduction would solve the problem.
3. Use a cosmetic with a different solvent base. Perhaps another solvent wouldn't act as aggressively on the AES barrel as the current one.
4. Use different materials for the cap and barrel that would work better together. Perhaps the strength and/or heat expansion properties of other materials would prevent the cracking.

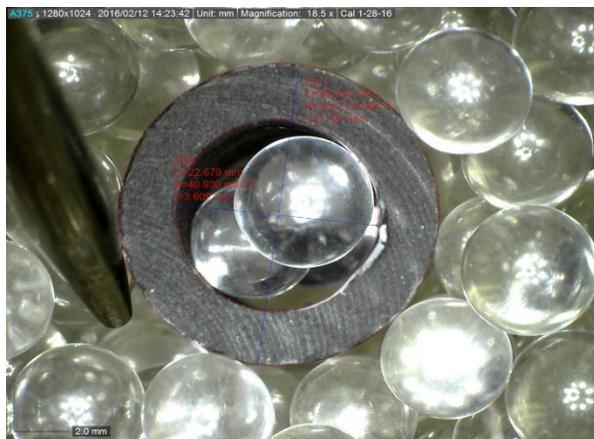
To investigate, TAL conducted another test of their own design. First, they placed a polypropylene cap and an AES barrel without cosmetic in two separate containers filled with glass beads. They then used a hot plate to gradually heat up the parts within each container, the glass beads conducting heat to the samples. TAL then observed with a microscope how the cap and barrel behaved as they were heated, taking measurements at 30°C, 40°C, and 50°C.

*AES barrel sample with dimensions during glass bead heat test.*

Over the course of the test, the polypropylene cap expanded more than the AES barrel, leading TAL to conclude that another possible reason for the cracking was merely the pressure of the polypropylene cap expanding against the AES barrel. The AES barrel, being a foamed product, would be likely to fail sooner than the polypropylene cap.

#### AES Barrel Dimensions over the Course of the Glass Bead Heat Test

Ambient (mm)		30° C (mm)		40° C (mm)		50° C (mm)		Radius Increase (mm)	
ID	OD	ID	OD	ID	OD	ID	OD	ID	OD
7.218	11.440	7.238	11.460	7.260	11.454	7.266	11.480	0.048	0.040

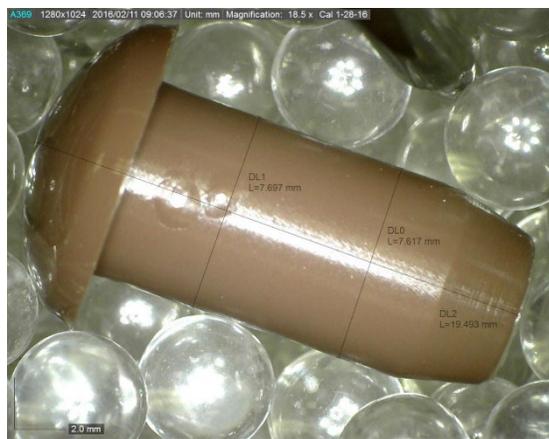
*Polypropylene cap sample with dimensions during glass bead heat test.*

#### Polypropylene Cap Dimensions over the Course of the Glass Bead Heat Test

Ambient (mm)		30° C (mm)		40° C (mm)		50° C (mm)		Width Increase (mm)	
Width 1	Width 2	Width 1	Width 2	Width 1	Width 2	Width 1	Width 2	Width 1	Width 2
7.617	7.697	7.775	7.851	7.786	7.821	7.791	7.873	0.174	0.176
